Forward Proton Detector

Carley Martins
Dzero/FPD
On site activities

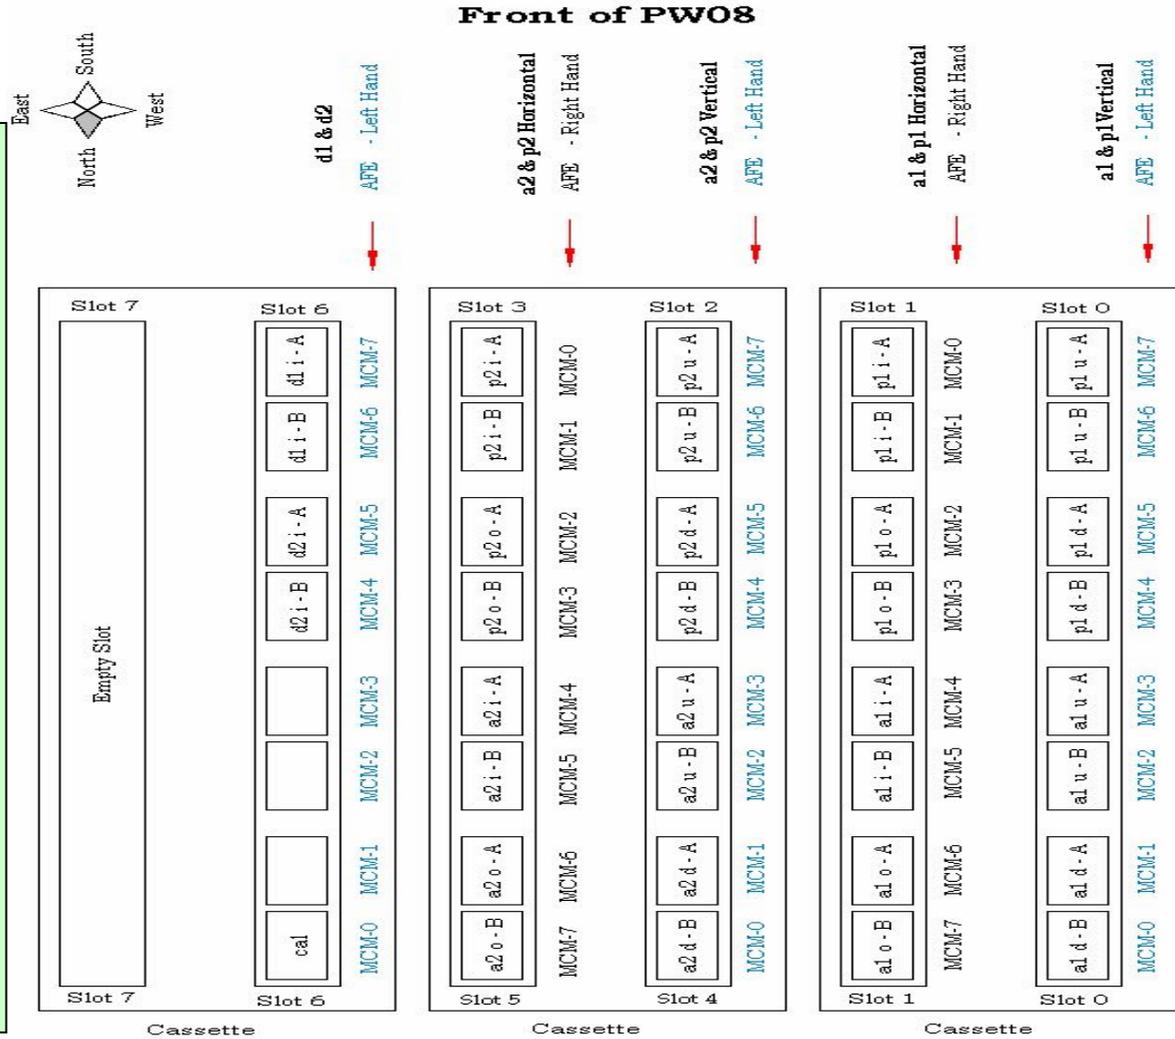
Transition Patch Panel (TPP) boards and AFE
(Rack PW08 on Collision Hall)

Very small space to accommodate cables and boards inside rack !!

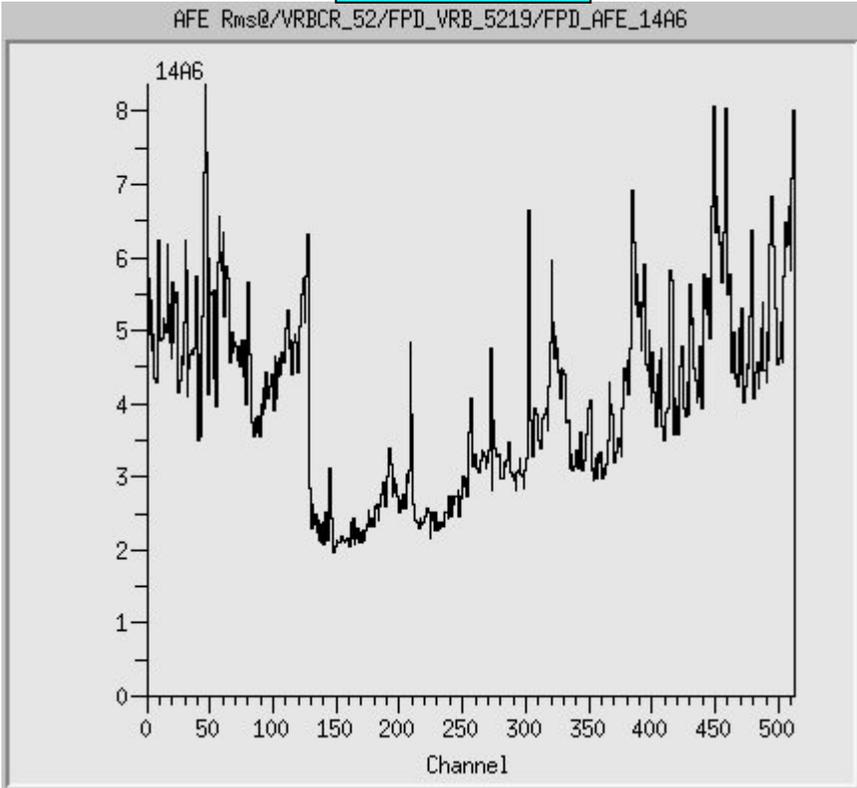
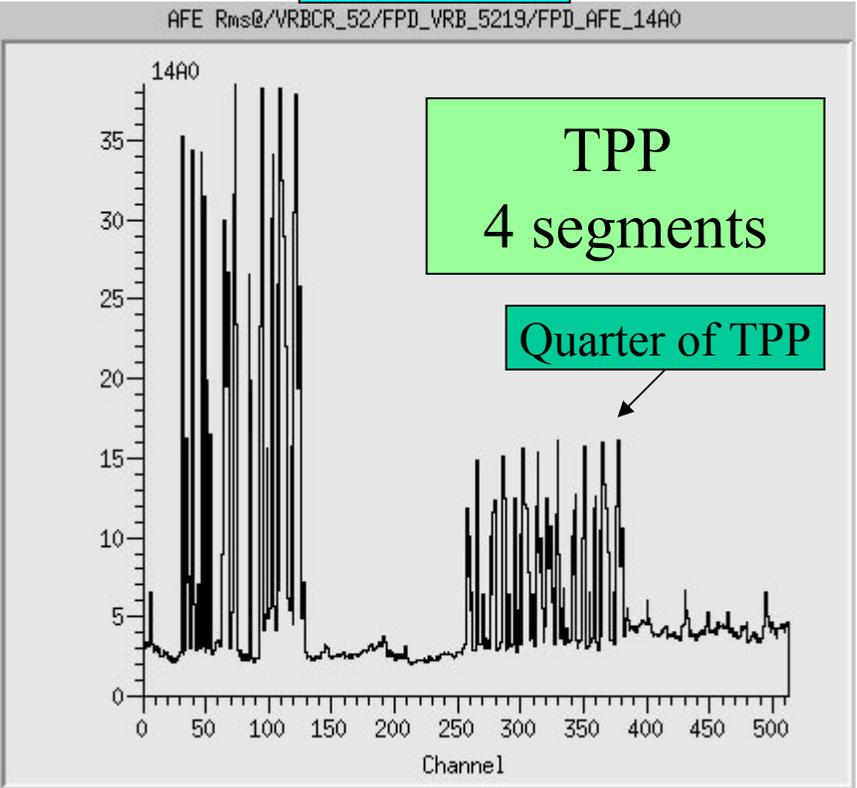
A1 Up

TPP: Noise Problem

Timing for FPD => Pedestal runs and calibration

Dipole

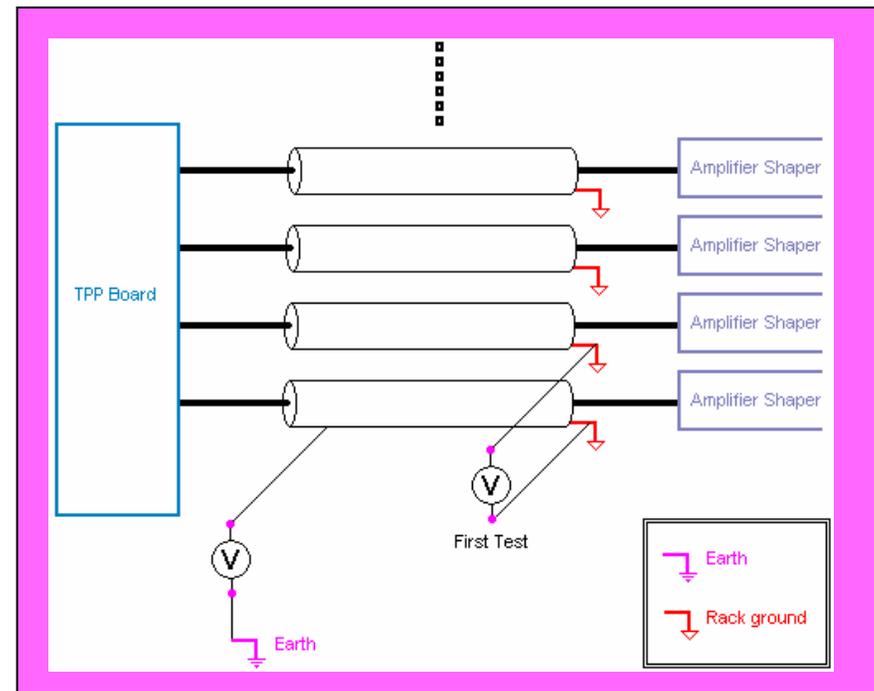
Ribbon cables status

Ribbon cables tests
For A1_up:
return lines for all
channel was
checked

**~ 10% of the total
channel was dead**
